Manhole Inspection Summary

Manhole # S45I2_010MH

Insp Date: **6/10/09 2:40 PM**

Location Address: **Fairhaven-pennington Alley**

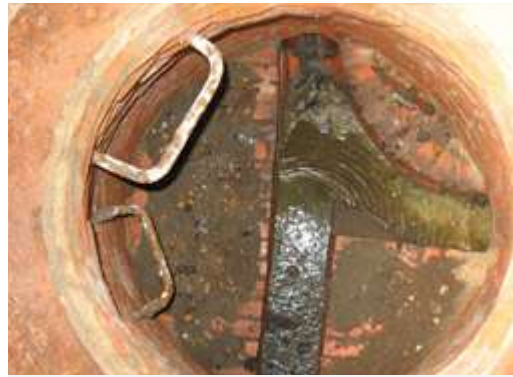
Top View

Comments **There is no influent pipe at 6 o'clock just a channel.**

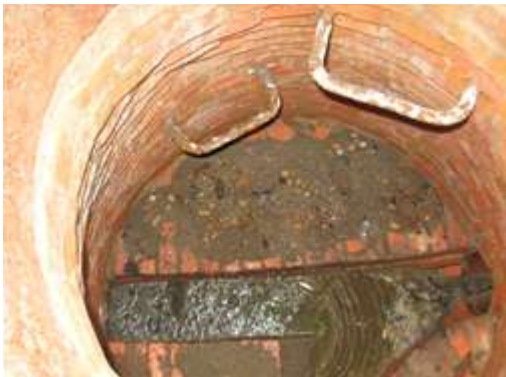
Steps Count: **2** Missing: **0** ☐ Corroded

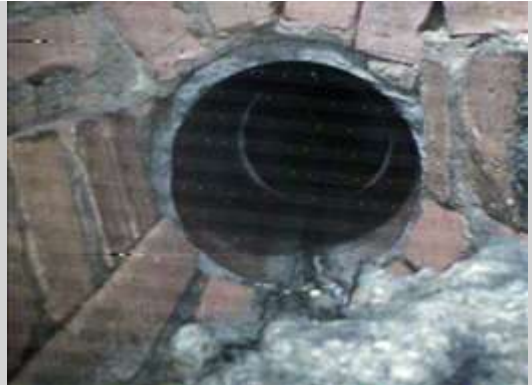
12 O'Clock Outflow

8 in. Circular Gravity Sewer
Pipe Out @ 12 O'Clock

Invert Depth: **5.30** (ft.) Flow Characteristics: **Slow**

Deposits: ☒ None ☐ Mud ☐ Sludge ☐ Debris ☐ Grease

Infiltration: **None** Pipe Seal Cond: **Sound**

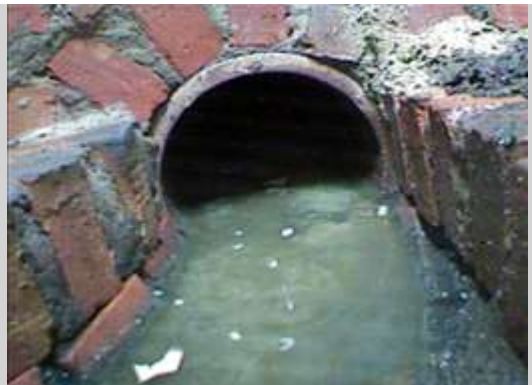
3 O'Clock Inflow

8 in. Circular Gravity Sewer
Pipe In @ 3 O'Clock

Invert Depth: **5.30** (ft.) Flow Characteristics: **Slow**

Deposits: ☒ None ☐ Mud ☐ Sludge ☐ Debris ☐ Grease

Infiltration: **None** Pipe Seal Cond: **Sound**

Connects To: **Dead End**
